Document RB-9

# **INCRUSTATIONS IN FUEL OIL STEAM BOILERS**

**rb bertomeu S.L.**  
**Technical Dept.**  
**1999. Updated 2015**

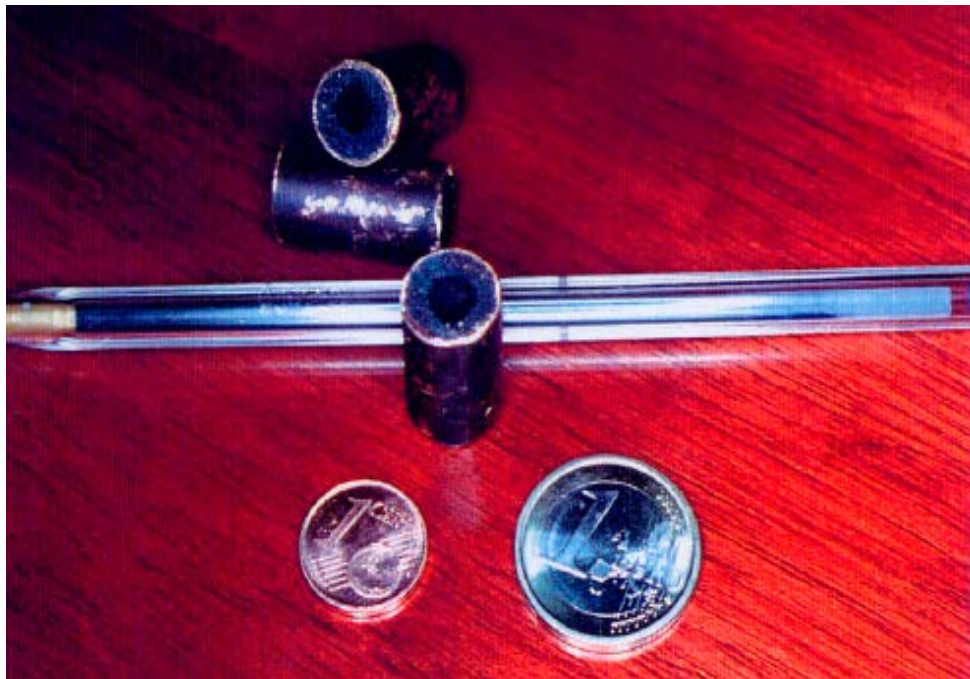
**PHOTO No. 1** : A steam boiler economiser, after several months’ operation, with the accumulated residues clearly visible. Note that the carbonaceous incrustations represent approximately 75% of the pipe’s section, which had to be dismantled due to the insufficient flow and fuel temperature feeding the burner.

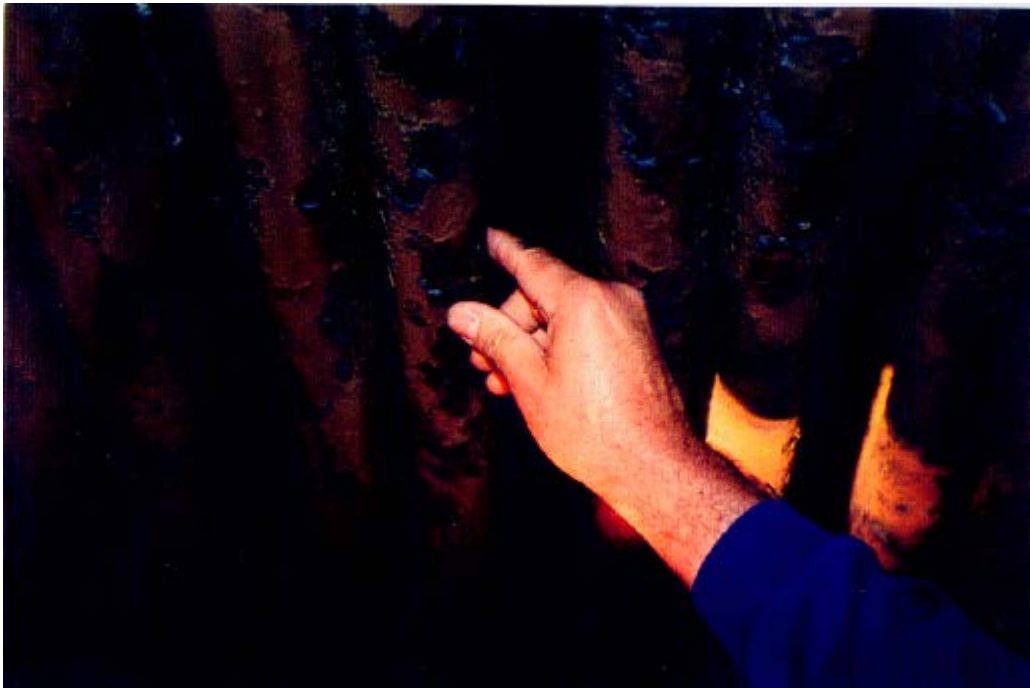
**PHOTO No. 3** : A steam boiler heat exchanger, after several months operating, where the incrustations covering the exchanger tubes are clearly seen.

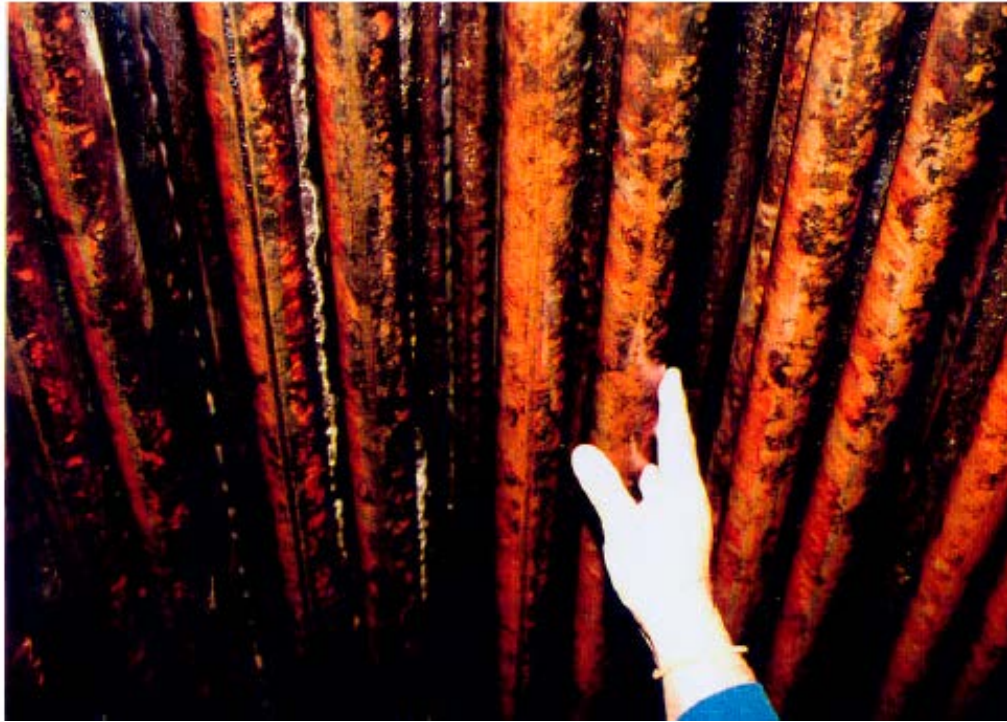
**PHOTO No. 4** : The same heat exchanger as in photo No. 3, after a scheduled cleaning. It can be seen that the pipes are completely incrustations-free.

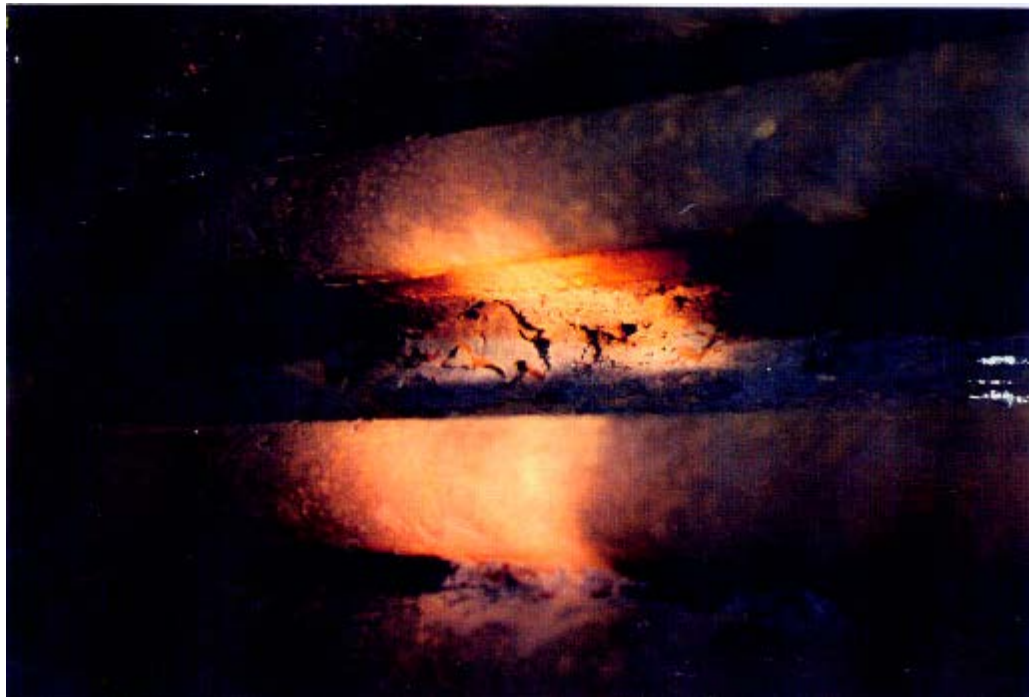
**PHOTO No. 5** : Magnified detail of the heat exchanger with incrustations as shown in Photo No. 3.

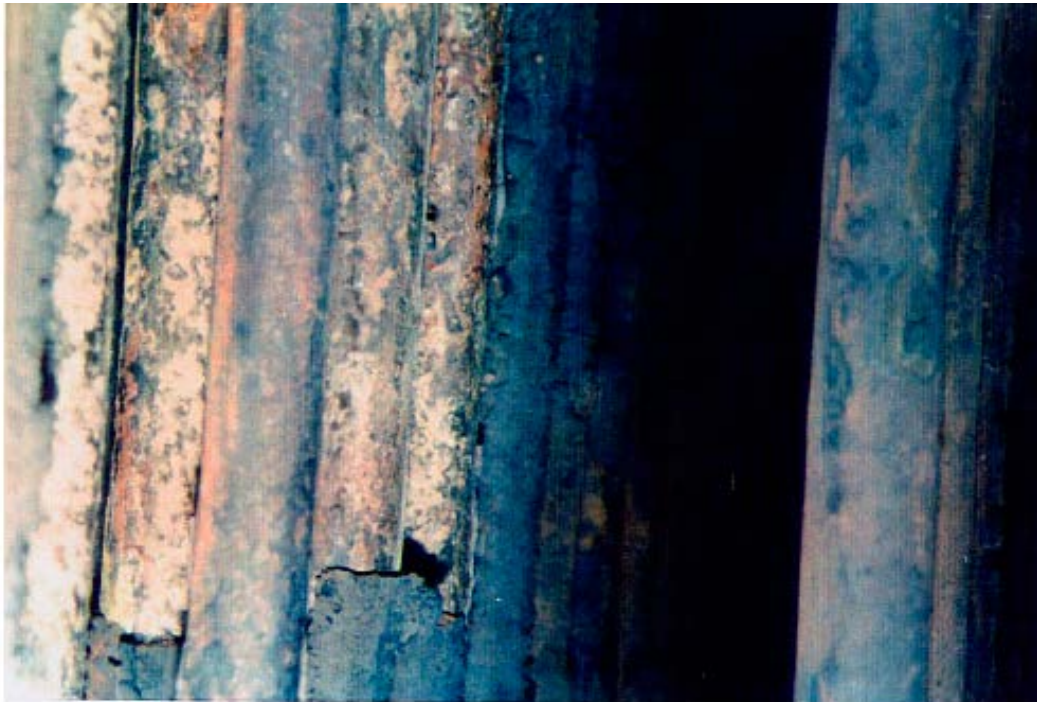
**PHOTO No. 7** : A heat exchanger from another steam boiler after several months in operation. The extent of the accumulated incrustations on the heat exchanger tubes can be clearly seen.

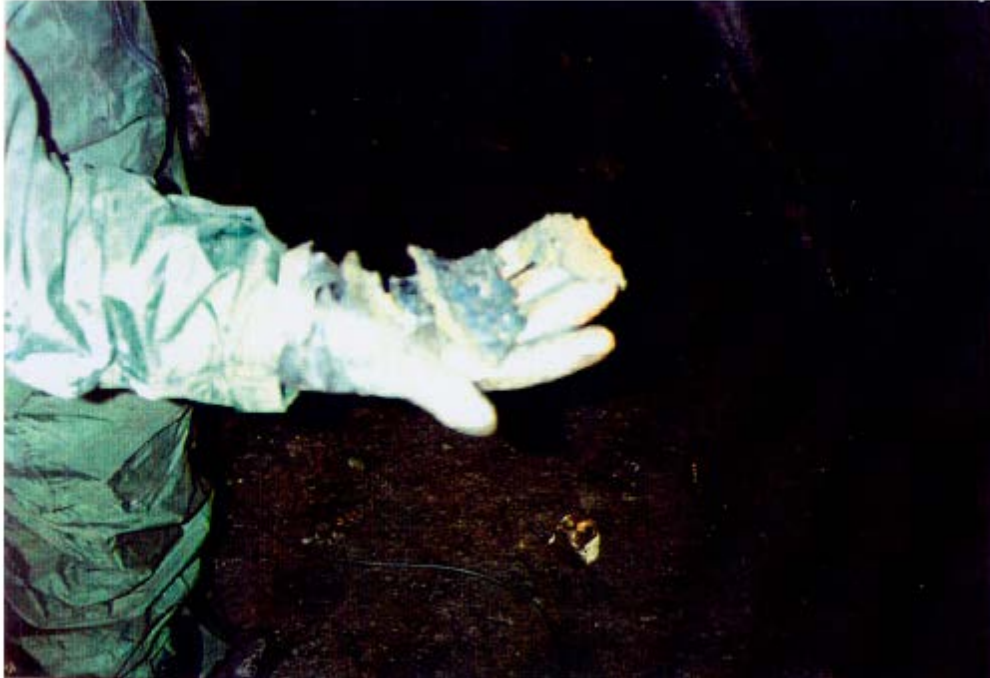
**PHOTO No. 8** : A fragment of incrustation, extracted from the heat exchanger in photo No. 7, with a thickness of about 10 mm.

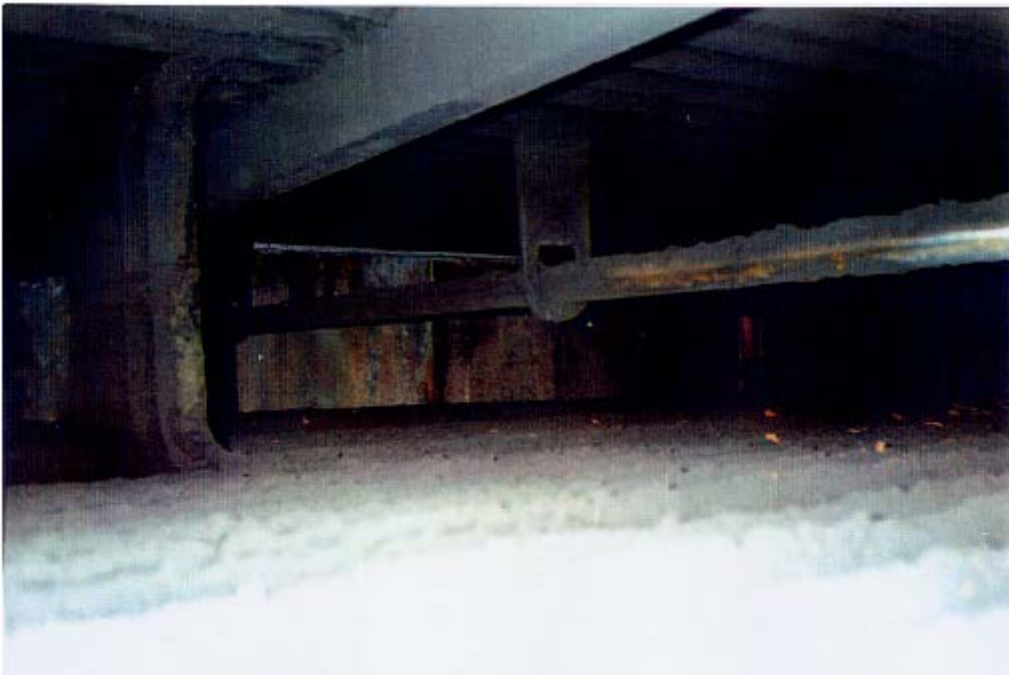
**PHOTO No. 9**

**PHOTO No. 9 :** A steam boiler economiser, after several months operating. Observe the powdery appearance of the residues deposited – in contrast to those in the previous photos.

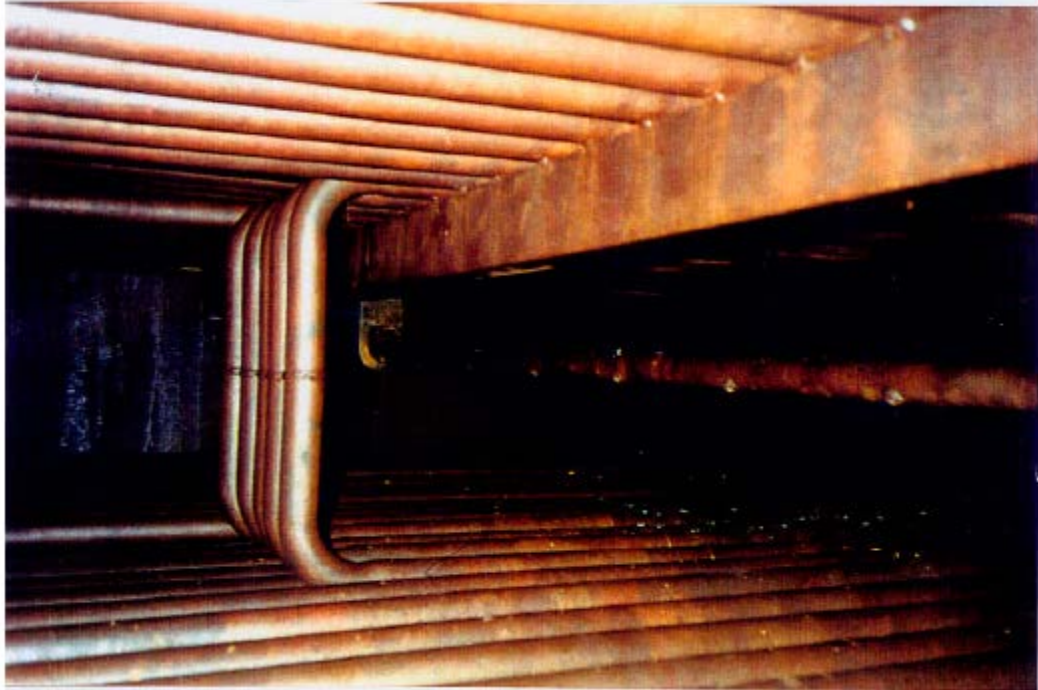
**PHOTO No. 10**

**PHOTO No. 10 :** The same economiser as in Photo No. 9 after a routine clean. It can be seen that the heat exchanger tubes are completely clean and free from signs of corrosion.
