Document RB-9

INCRUSTATIONS IN FUEL OIL STEAM BOILERS

rb bertomeu S.L.
Technical Dept.
1999. Updated 2015

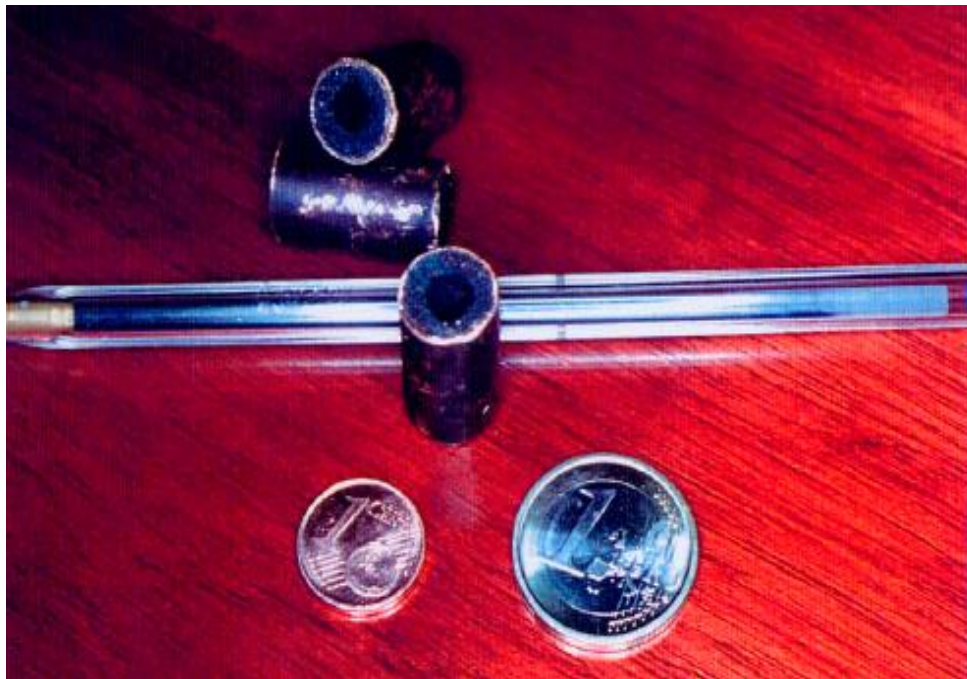
PHOTO No. 1 : A steam boiler economiser, after several months’ operation, with the accumulated residues clearly visible. Note that the carbonaceous incrustations represent approximately 75% of the pipe’s section, which had to be dismantled due to the insufficient flow and fuel temperature feeding the burner.

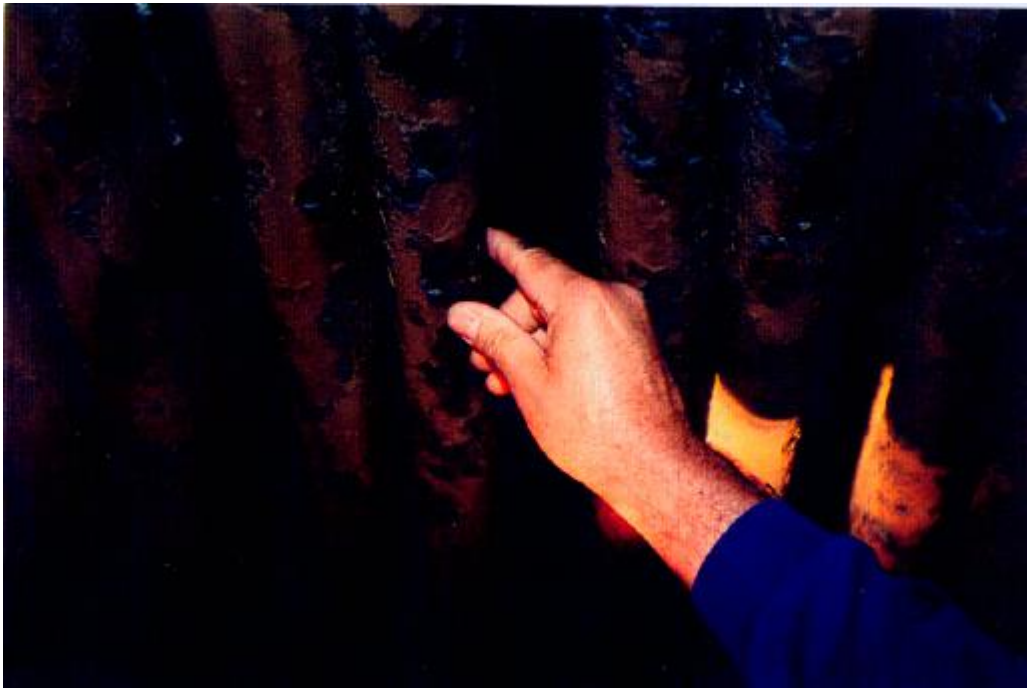
PHOTO No. 3 : A steam boiler heat exchanger, after several months operating, where the incrustations covering the exchanger tubes are clearly seen.

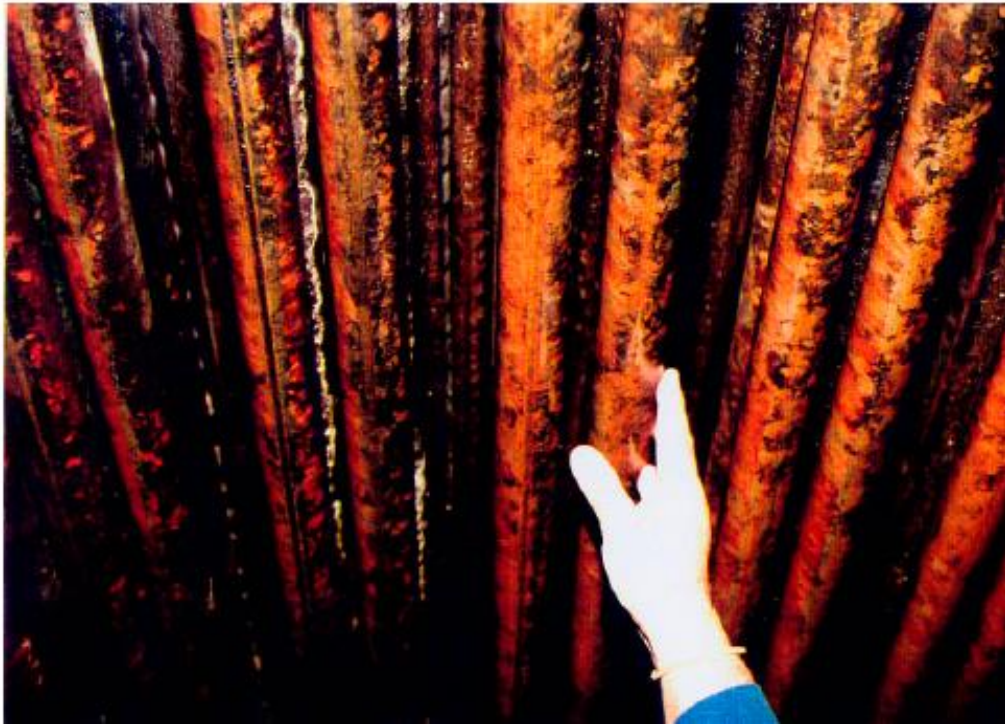
PHOTO No. 4 : The same heat exchanger as in photo No. 3, after a scheduled cleaning. It can be seen that the pipes are completely incrustations-free.

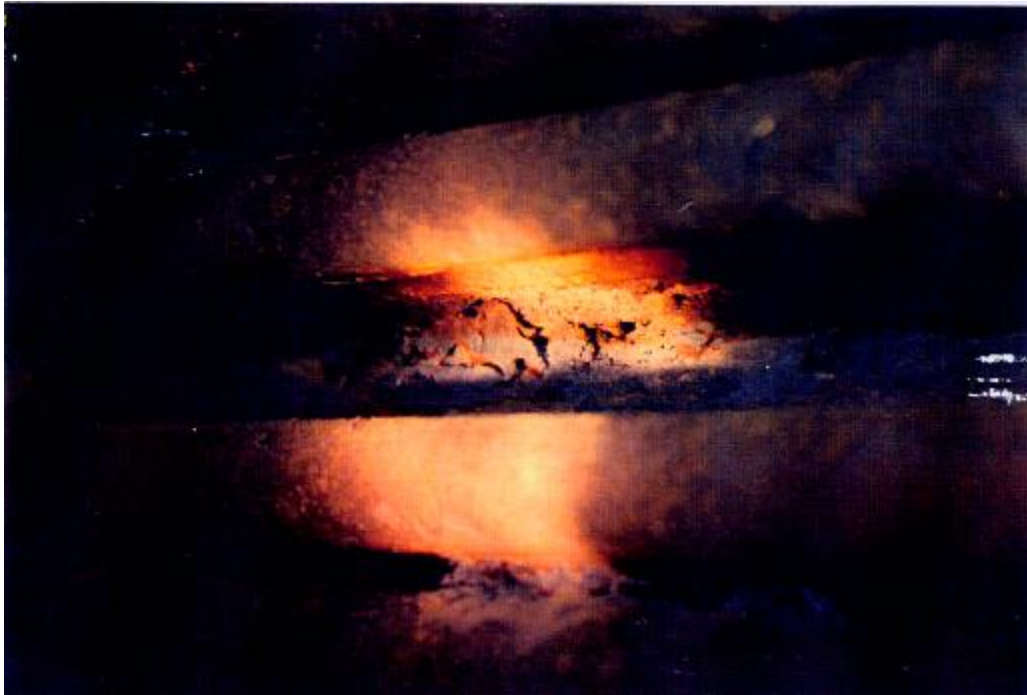
PHOTO No. 5 : Magnified detail of the heat exchanger with incrustations as shown in Photo No. 3.

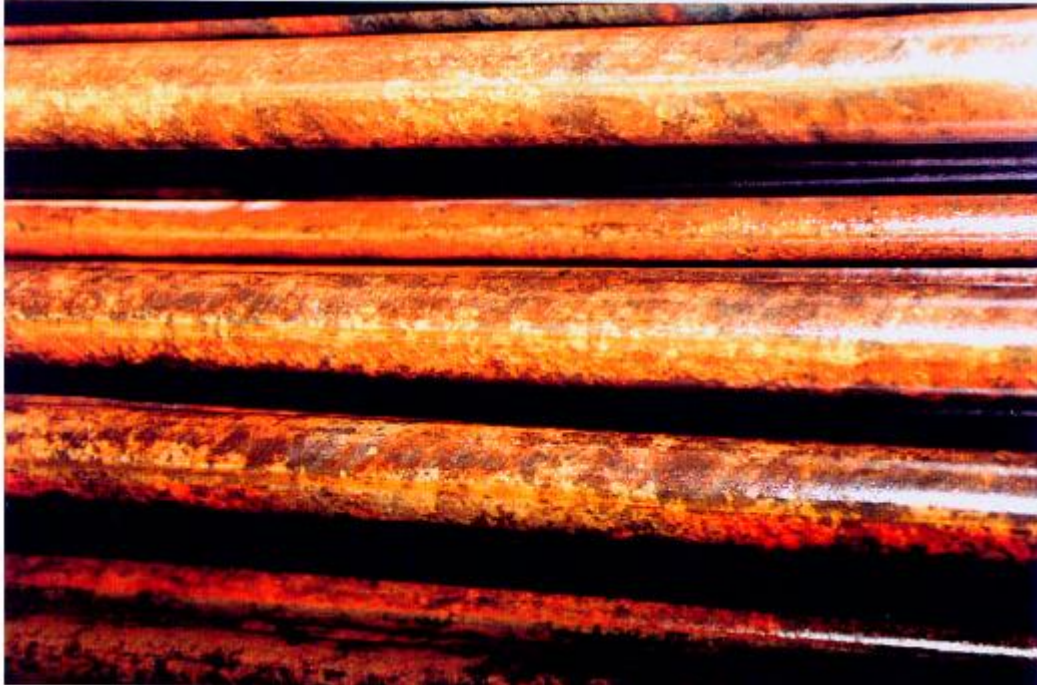
PHOTO No. 6 : Magnified detail of the clean heat exchanger as shown in Photo No. 4.

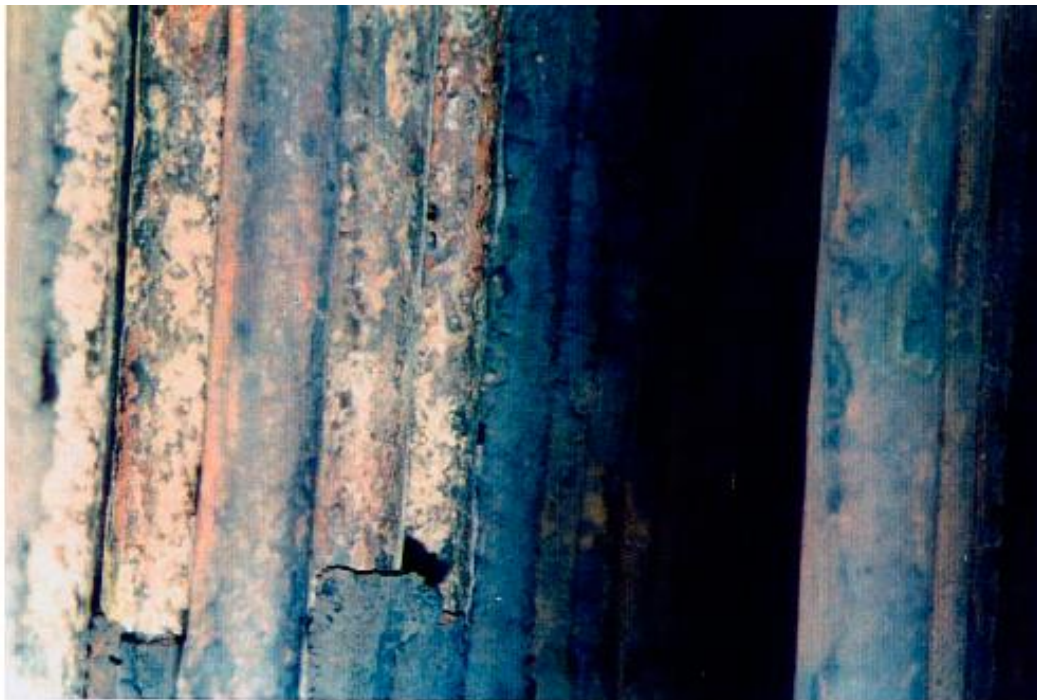
PHOTO No. 7 : A heat exchanger from another steam boiler after several months in operation. The extent of the accumulated incrustations on the heat exchanger tubes can be clearly seen.

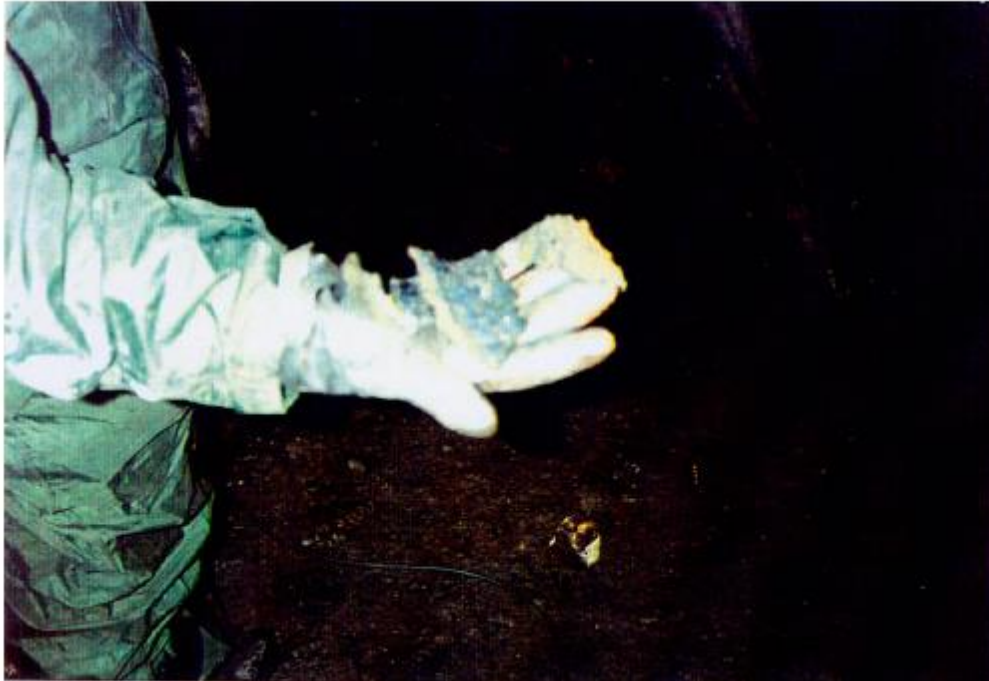
PHOTO No. 8 : A fragment of incrustation, extracted from the heat exchanger in photo No. 7, with a thickness of about 10 mm.

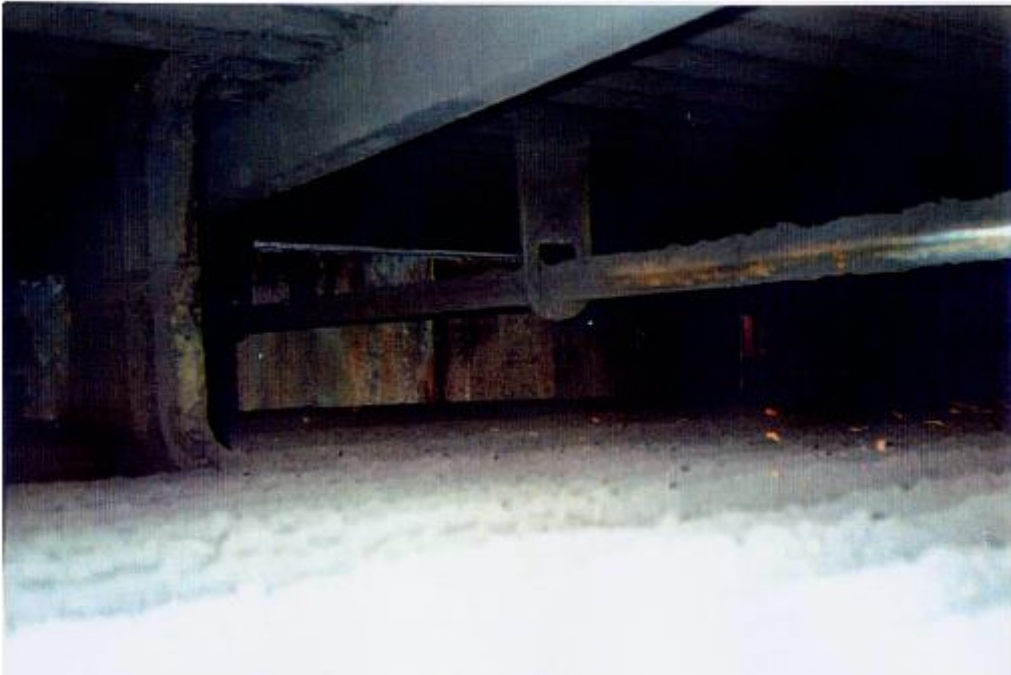
PHOTO No. 9 : A steam boiler economiser, after several months operating. Observe the powdery appearance of the residues deposited – in contrast to those in the previous photos.

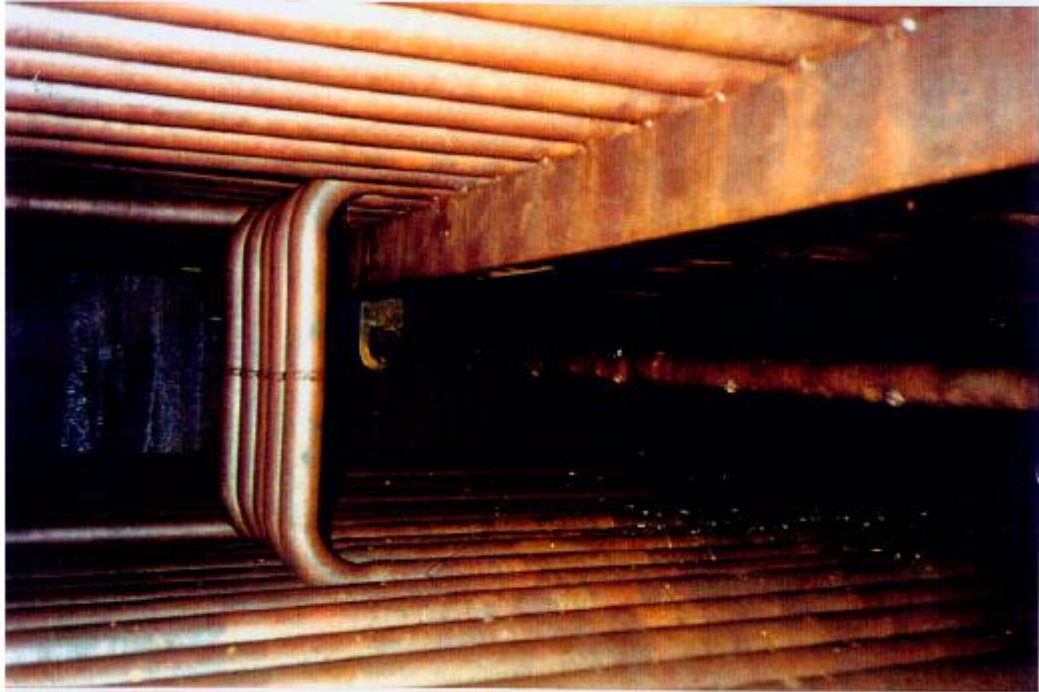
PHOTO No. 10 : The same economiser as in Photo No. 9 after a routine clean. It can be seen that the heat exchanger tubes are completely clean and free from signs of corrosion.
